## Rock Springs, WY Fire Department Pumper Refurb

# Rock Springs Pumper

## Refurb Specs

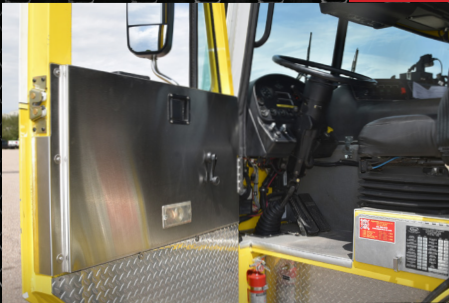
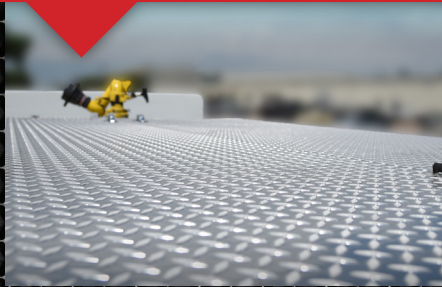
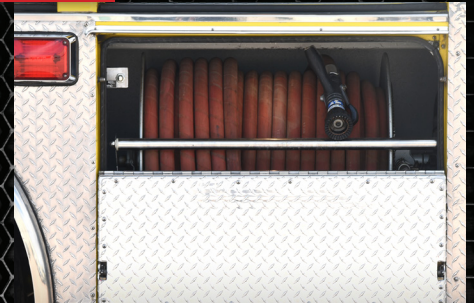
After **SVI Refurb**

- Front Brake Replacement
- LED Cab Interior Lighting Upgrade
- Tank Level Gauge LED Readout Replacement
- Powered and Heated Side Mirrors Addition
- New Interior Stainless-Steel Door Panel Fabrication
- Gold Leaf Engine Number Graphics
- Diamond Plate Aluminum Hose Bed Cover Installation
- Curbside Lower Compartment Doors Fabrication
- Spotlight, Headlight and Tailgate LED Upgrade

- Repair rear compartment rust
- Apply cab/chassis undercarriage cleaning and undercoat
- Fabricate interior stainless-steel door panel
- Replace latch, closures and weather stripping on rear compartment doors and cab interior doors/panels
- Fabricate curbside lower compartment doors out of tread plate

- Overhaul in-frame engine
- Overhaul transmission
- Replace front brake
- Replace odometer gauge
- Replace corroded battery box

- Upgrade cab interior lighting LED
- Replace tank level gauge with LED readout
- Upgrade headlight and taillight LED
- Add rear lower LED warning lights
- Upgrade spotlight LED
- Repair step light
- Repair front spotlight
- Repair rear tailboard marker lights (secured using silicone)

- Provide pump plumbing and linkage inspection
- Provide pump test
- Rebuild intake and discharge valve
- Upgrade pump panel light LED
- Relace water pump front and back seal
